Midmark® Manual and Power Exam Tables New Parts to fit 100 Series and 411 (75L)

TECH TALK Tuttnauer Door Bellows Stuck in the Locked Position And Now Pressure Is Building

Belmont Clesta® Front Shield Cracking

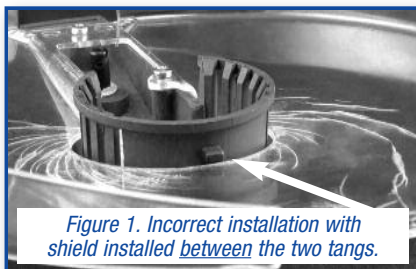
Figure 1. Incorrect installation with shield installed between the two tangs.

Now and then RPI will have a customer return a Belmont Clesta Front Shield (RPI Part #BES044) for cracking right after install. These cracks are curved and radiate out from the center opening towards the right side lens mount (see Figure 1 below). The reason for these cracks is an incorrect installation of the front shield.

Beware! If you install the domed pie pan style shield between the two tangs and then secure it to the lamp head, you will over stress or flex the shield then after a few uses of heating and cooling, the stress cracks appear. Figure 1 below shows a misinstalled shield and the stress cracks that it causes. Figure 2 below shows a correct installation of the domed pie pan style shield where the shield floats below the two tangs (*not between the two tangs*).

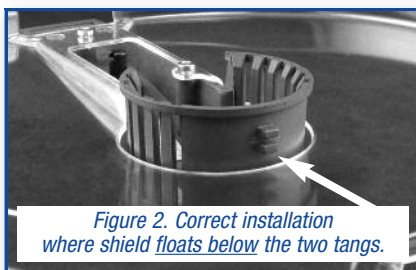
Figure 2. Correct installation where shield floats below the two tangs.

Belmont changed the shape of the front shield from a flat pancake to a domed pie pan style. With this new style, you no longer mount the shield between the two tangs. This new domed pie pan style shield now sits higher up the side of the lamp cover than the flat pancake style did.
